ROYAL COMMISSION

QUEBEC BRIDGE INQUIRY

1907

MINUTES OF PROCEEDINGS

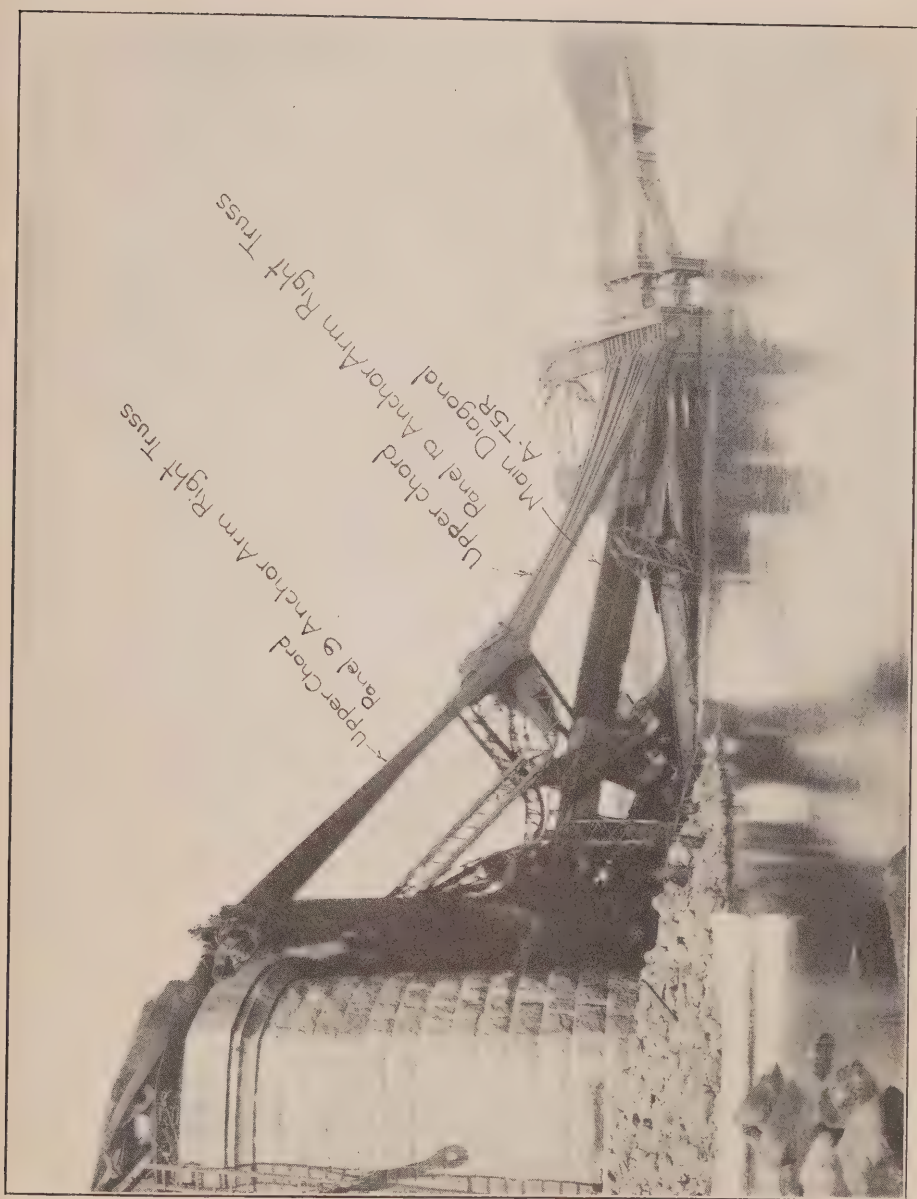
1. View showing the centre post cap, finials, diagonal T5 and the upper chords in panels 9 and 10 Anchor Arm. The centre post has been practically bent double over the main pier by the drag of the cantilever arm. Note that the end of the pier is clear of wreckage.

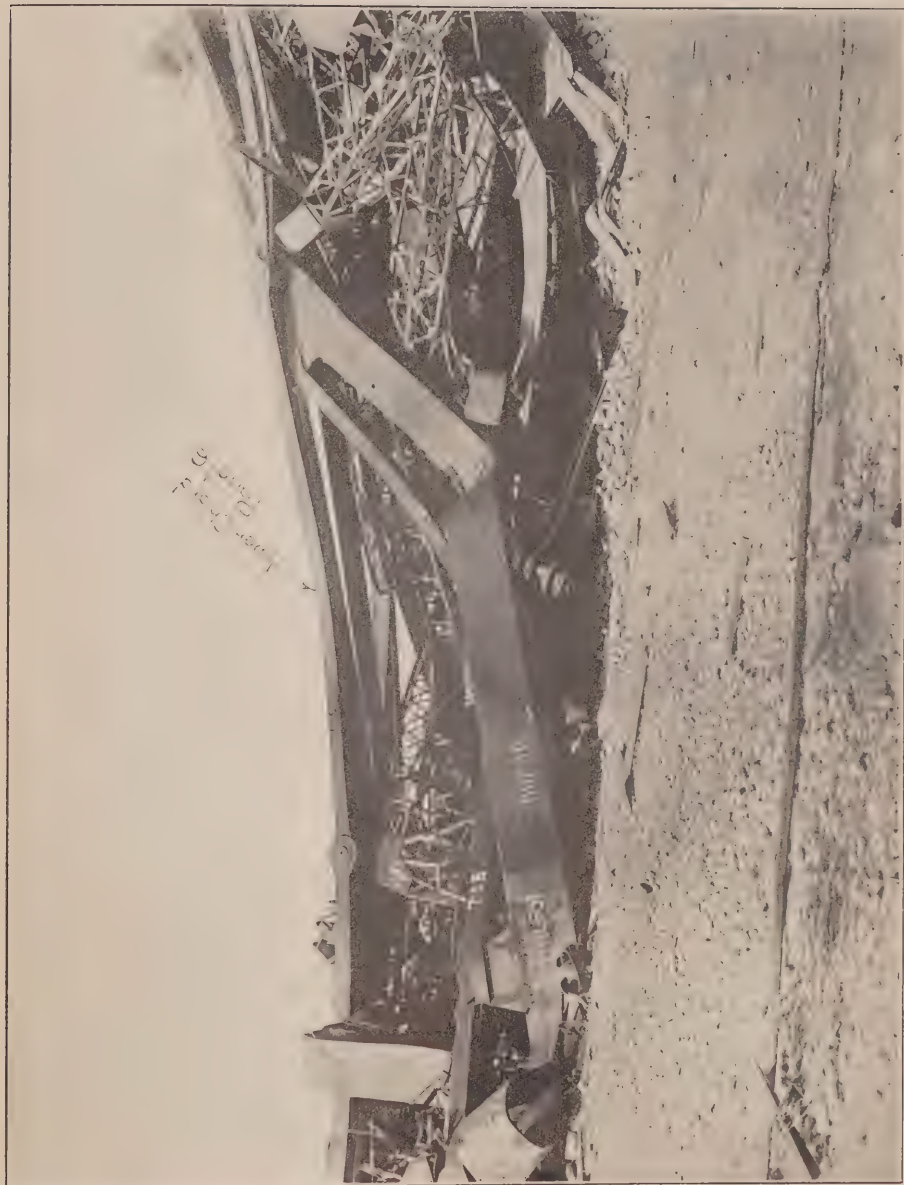
4. View of the same from a further distance. Note the distortions of ALP3R.

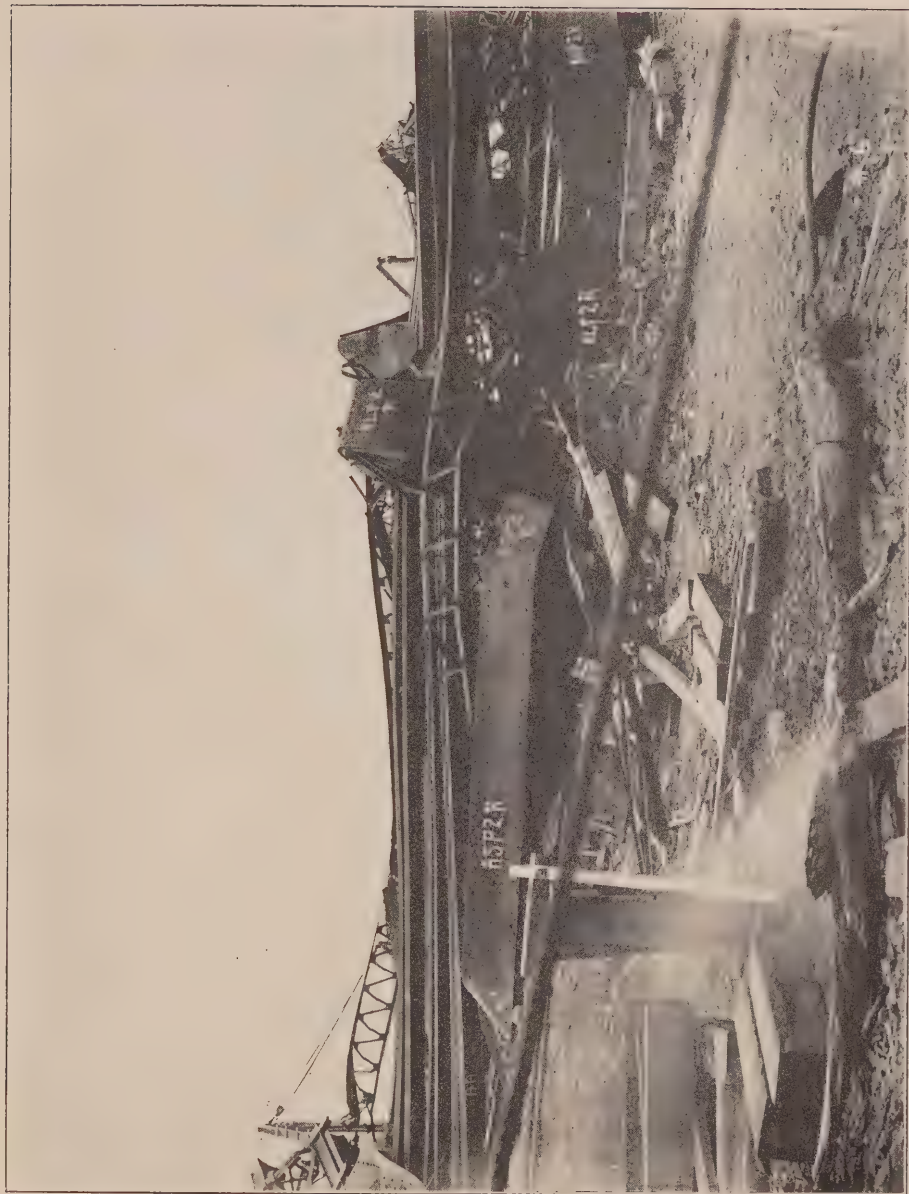
6. View of the foot of post P2R. Note the distortions of ALP2R, ASP2R and AUP2R, making one complete post.

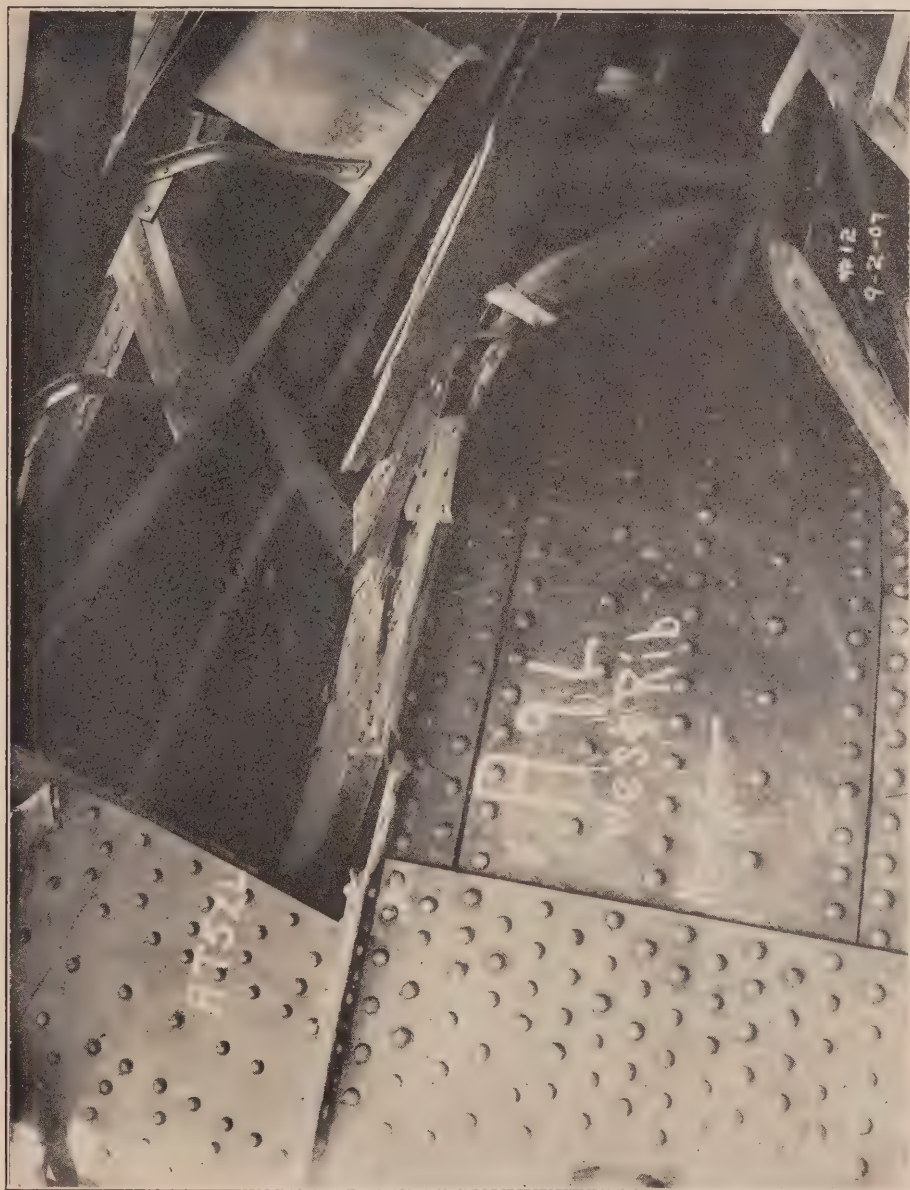
12. View from the west showing the beginning of the first 180° bend in chord A9L.

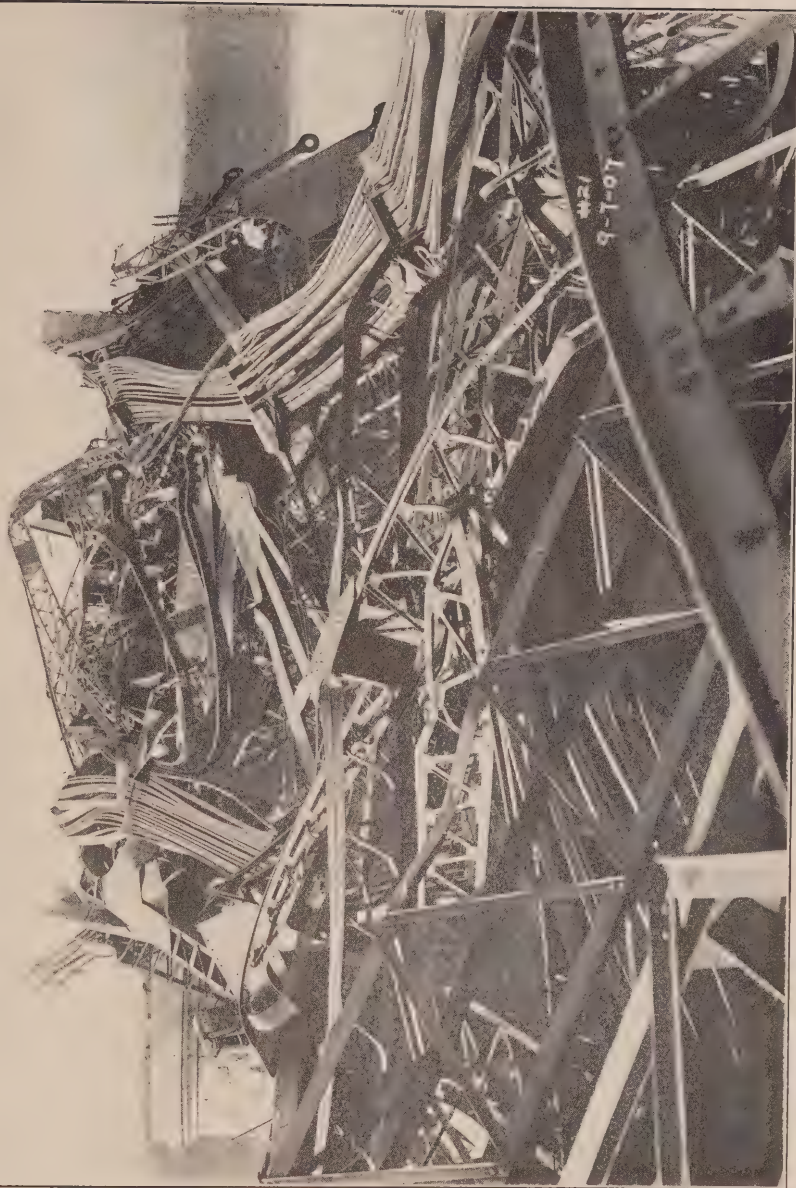
20. General view from the main pier southwards, Note the moderate damage to the upper laterals.

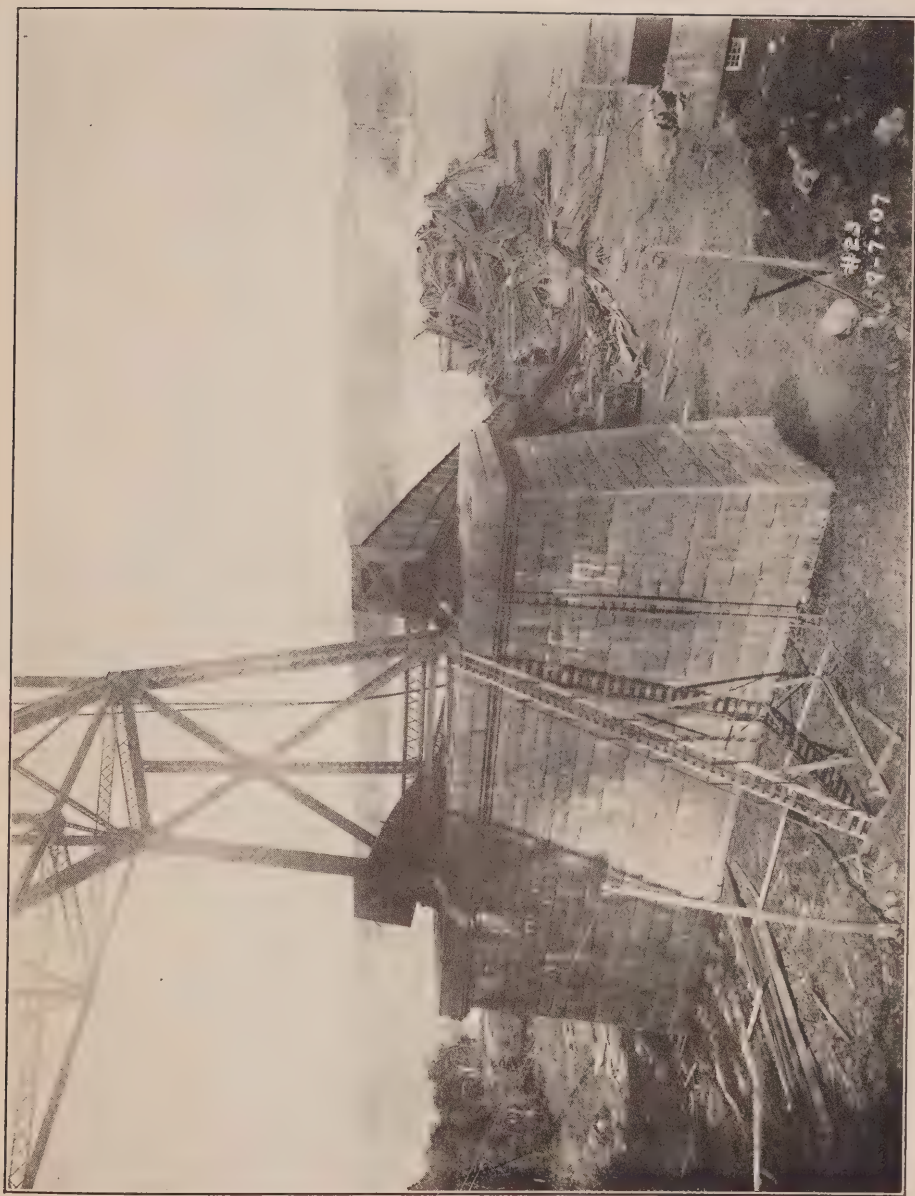
22. General view from the anchor pier northwards. Note the position of the wreckage on the main pier.

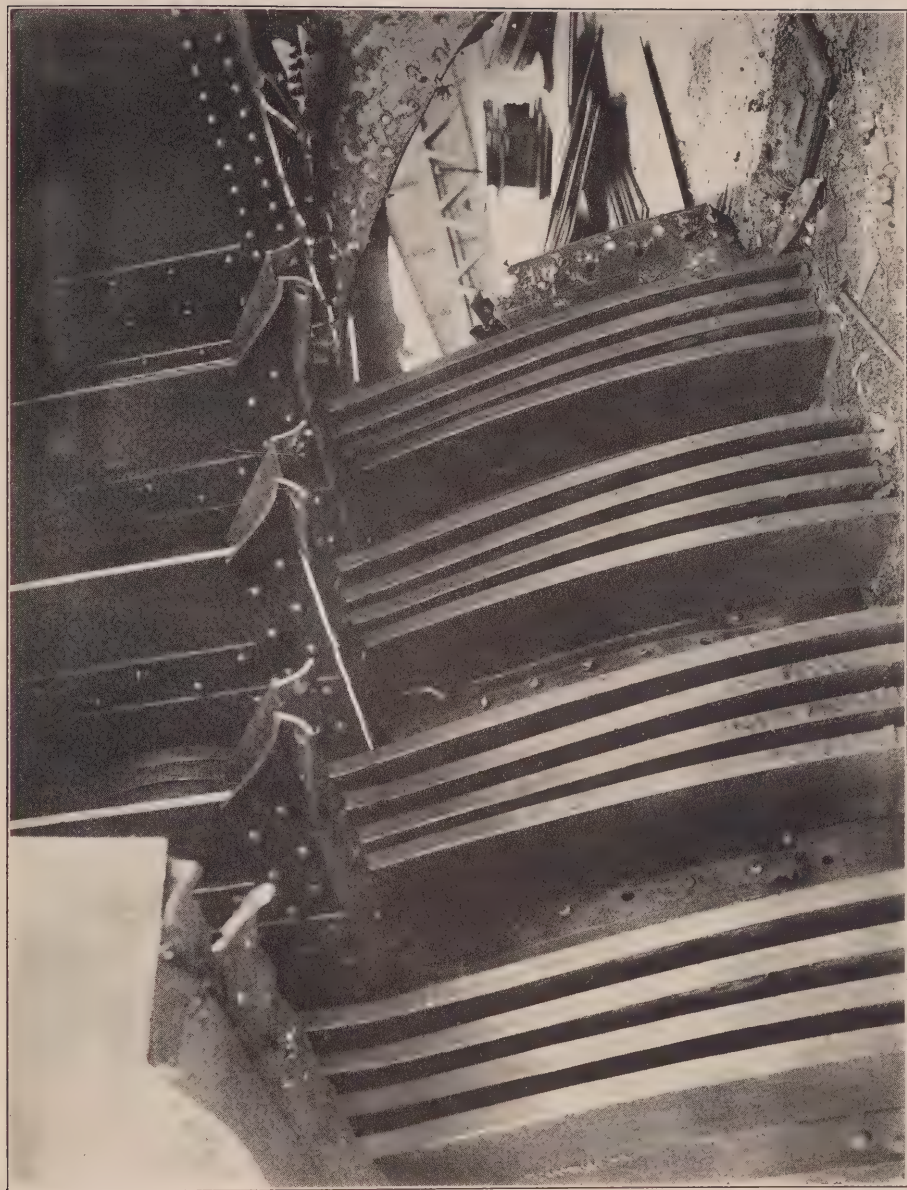
24. General view from the anchor pier northwards, same as No. 22, but from a different elevation. Note the unbroken lines of the upper chord.

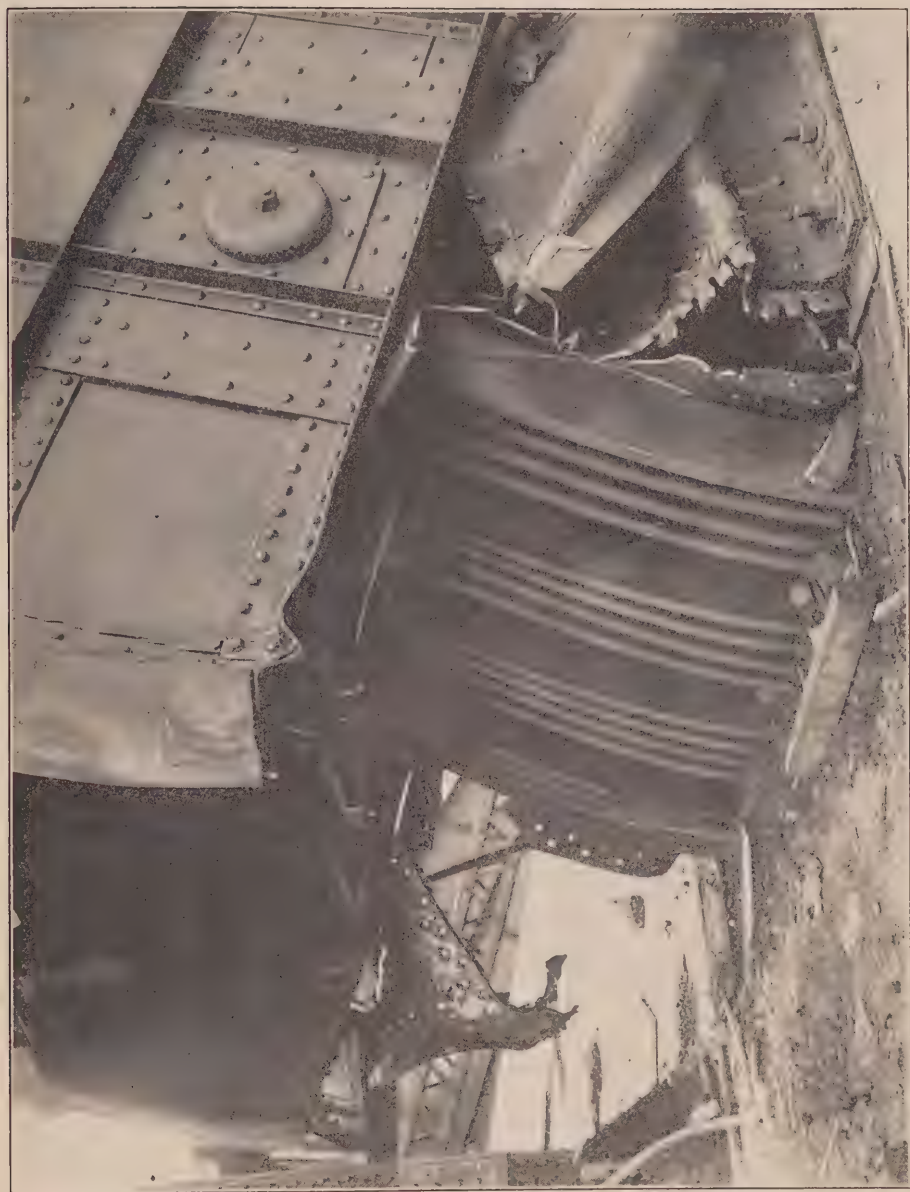
25. View of the anchorage of the right truss. Note the bendings of the anchorage bars; the scaling of the metal in them, and the folding and scaling of the tower shell.

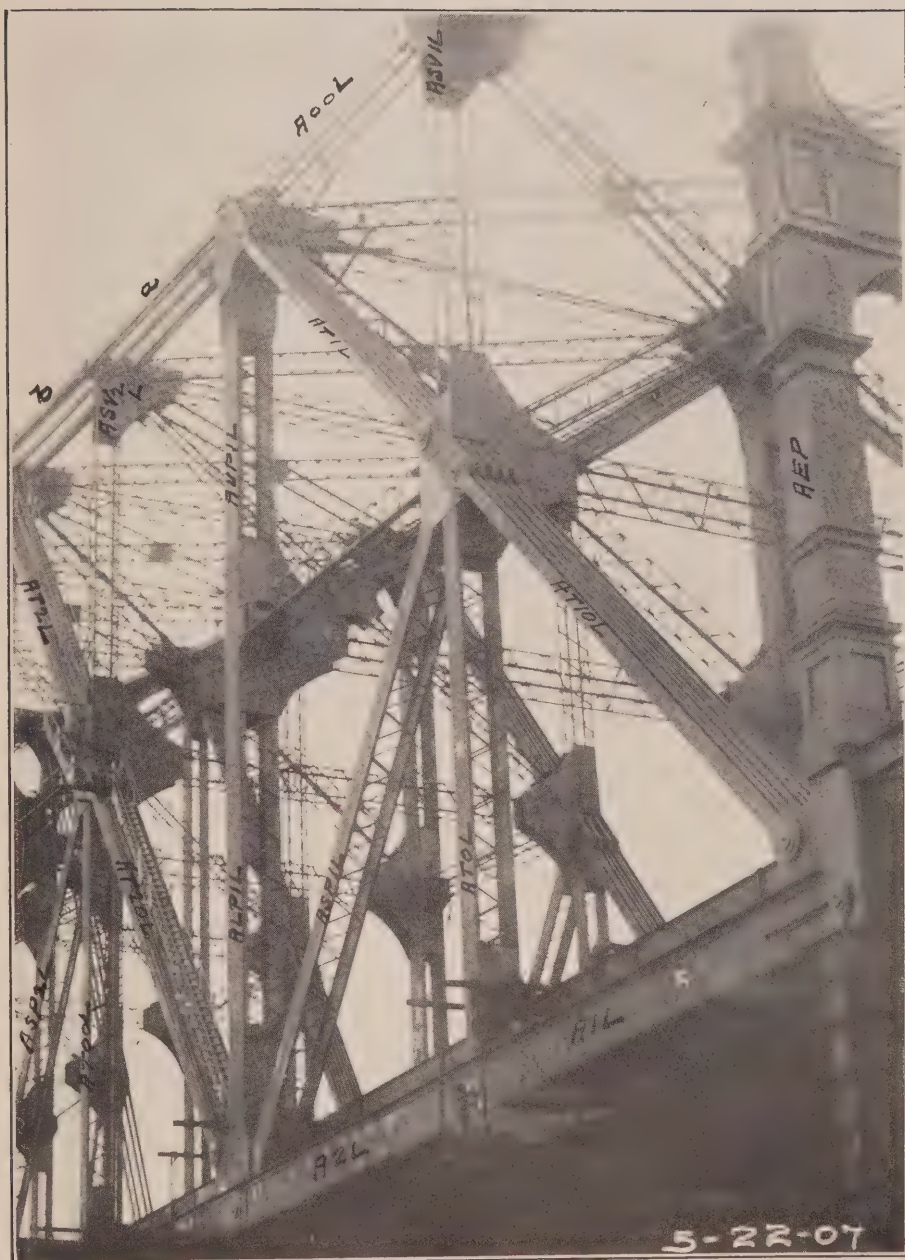
4. View of the first three panels of the anchor arm. Note the temporary stairway to the upper chord and the size of the connection plates at the intersections. The error in the original assumption of the dead load in the bridge was made by underestimating the weight of such details. Date, May 22, 1907.

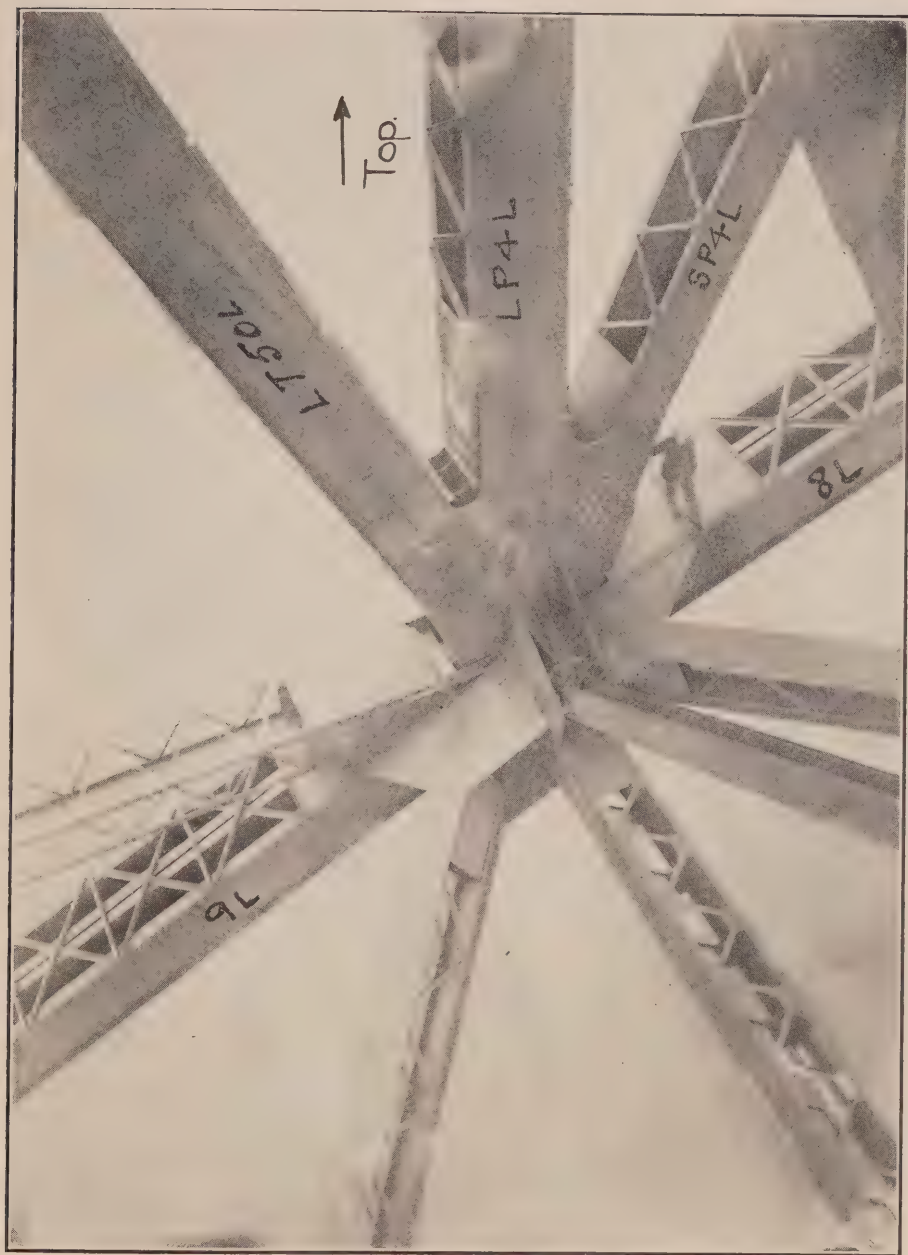
14. View of bottom chord intersection between panels 8 and 9, cantilever arm, west truss. The lower chords on the opposite truss (8-R and 9-R) are duplicates of those shown and were failing on August 27.

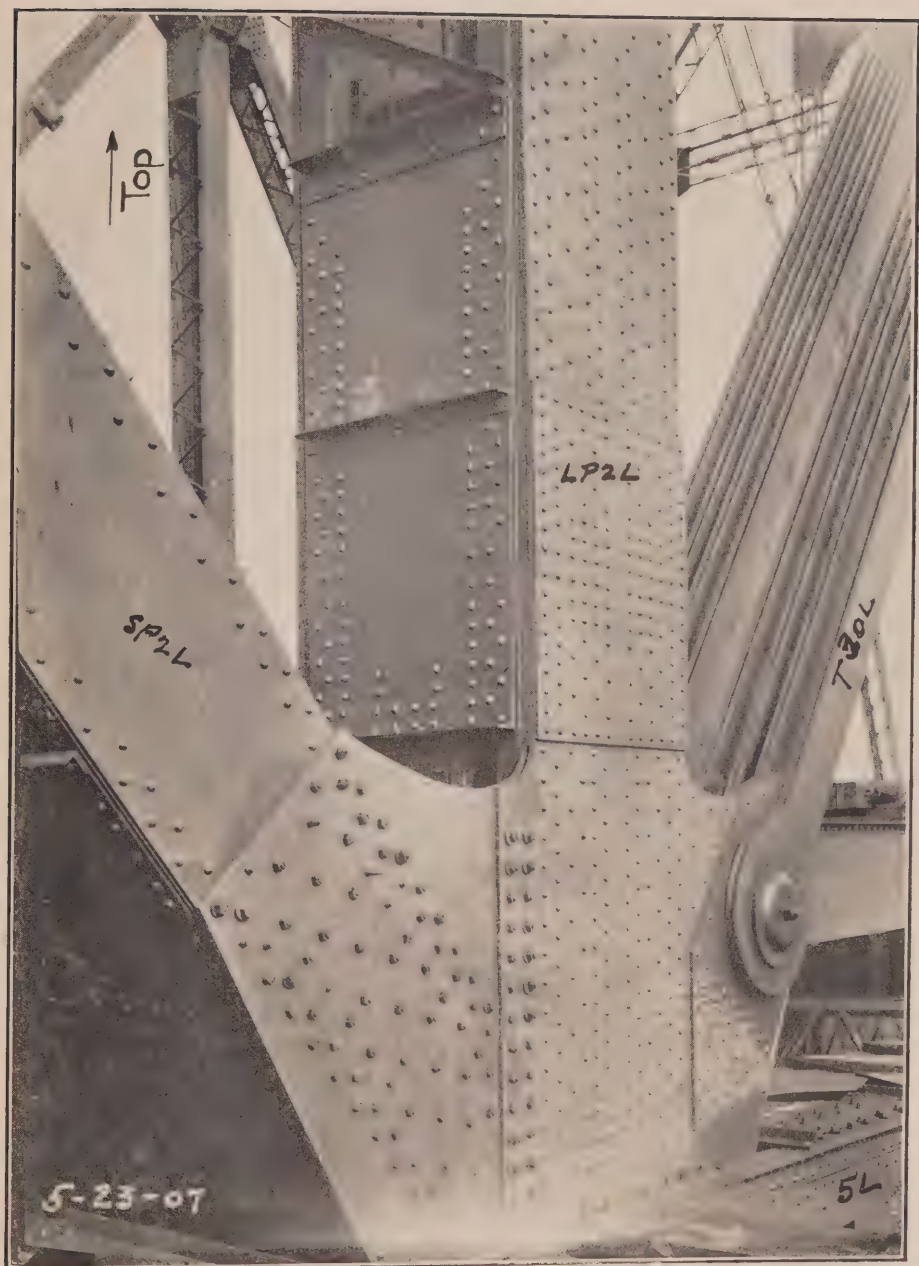
17. View of the foot of post P-2, left truss, cantilever arm. Note the bolting of the sub-post joint. Date, May 23, 1907.

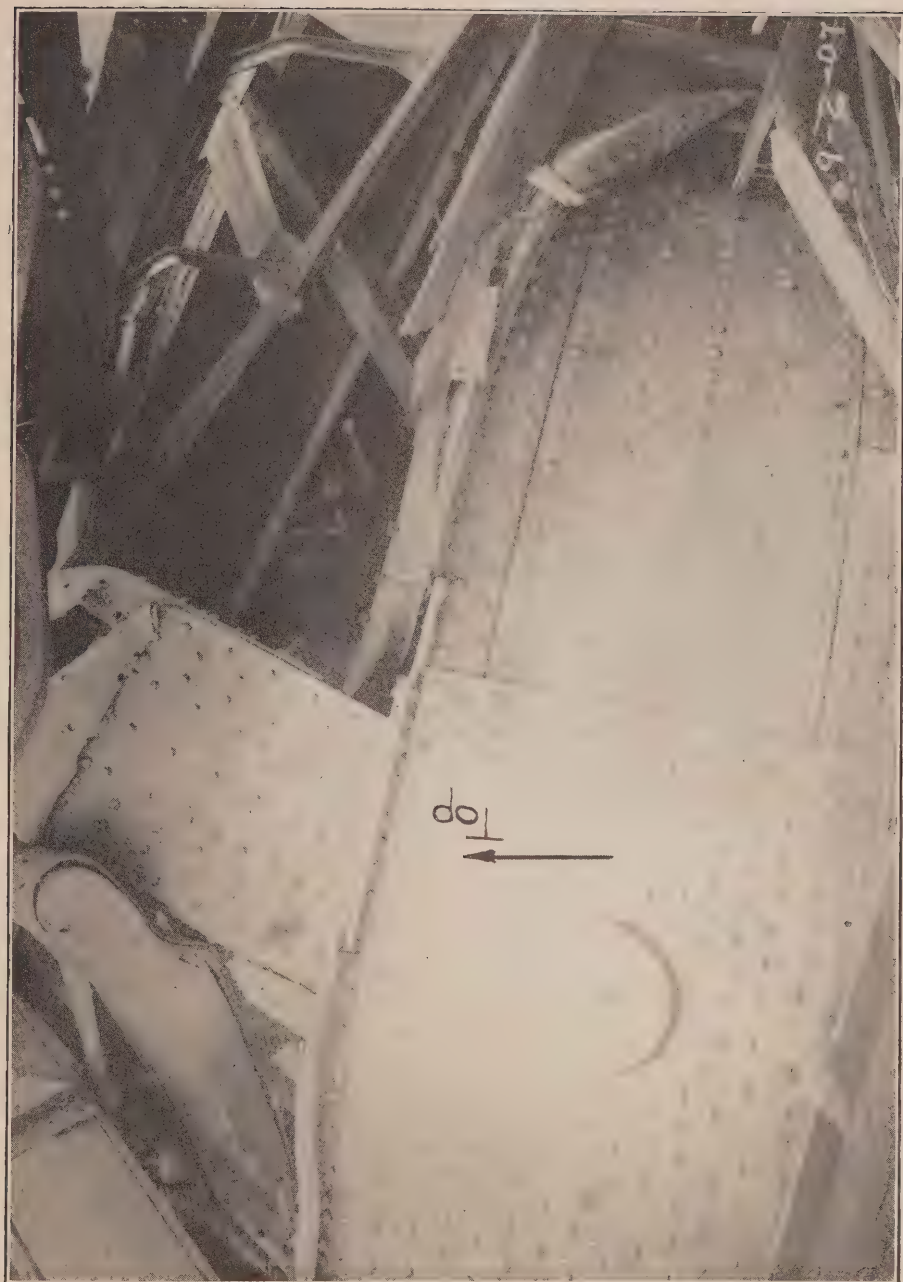
18. View of the shop splice between panels 9 and 10, left truss anchor arm. Note the bend in chord A 9 L. Date, Sept. 2, 1907.

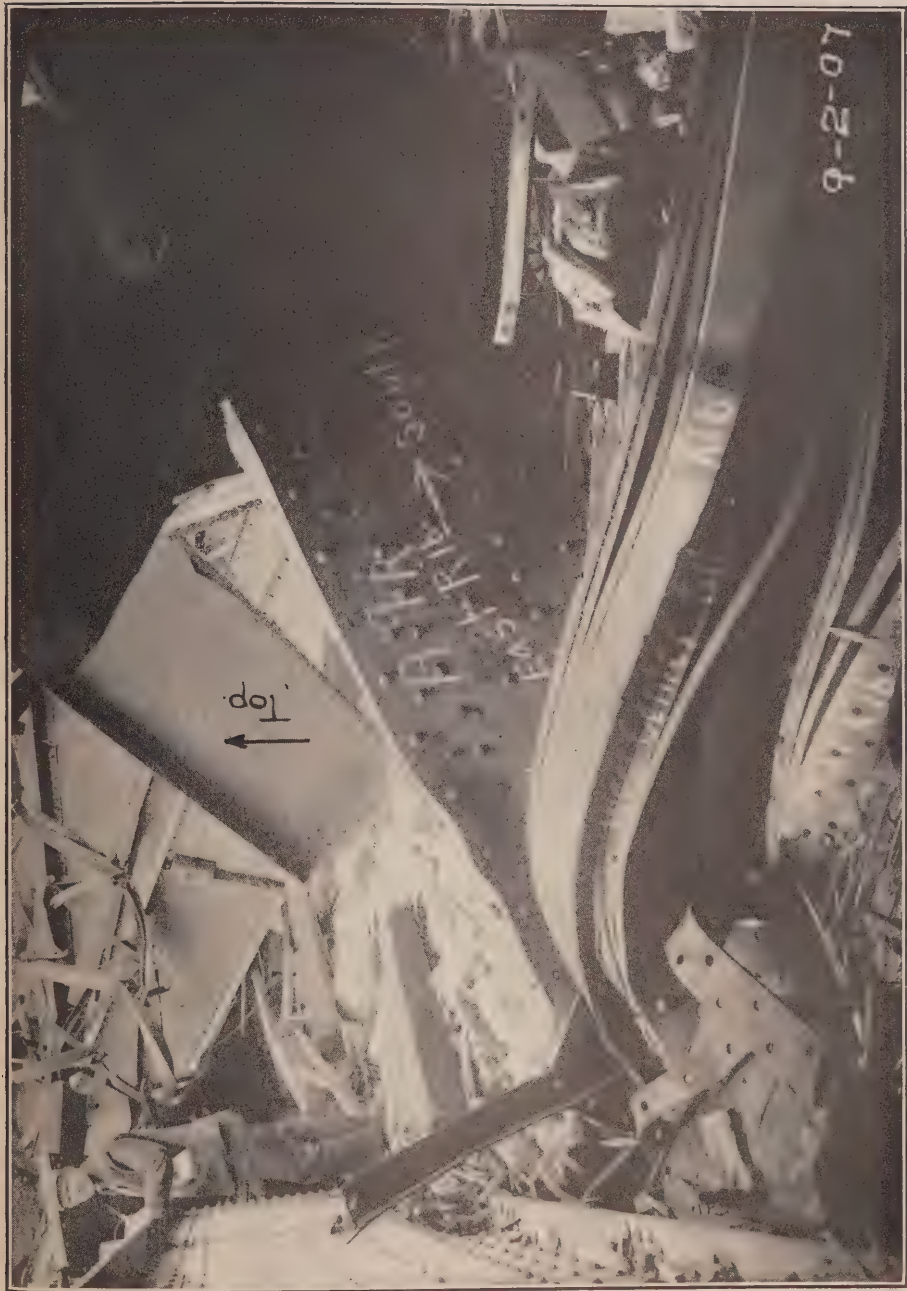
19. View of the wreckage of chord 9, right truss anchor arm. Note the bend of the ribs which is nearly 180 degrees near the lattice bar in the foreground, and the chord has been turned upside down. The lower chord in the left of the photograph is A-7-R. Date, September 2, 1907.

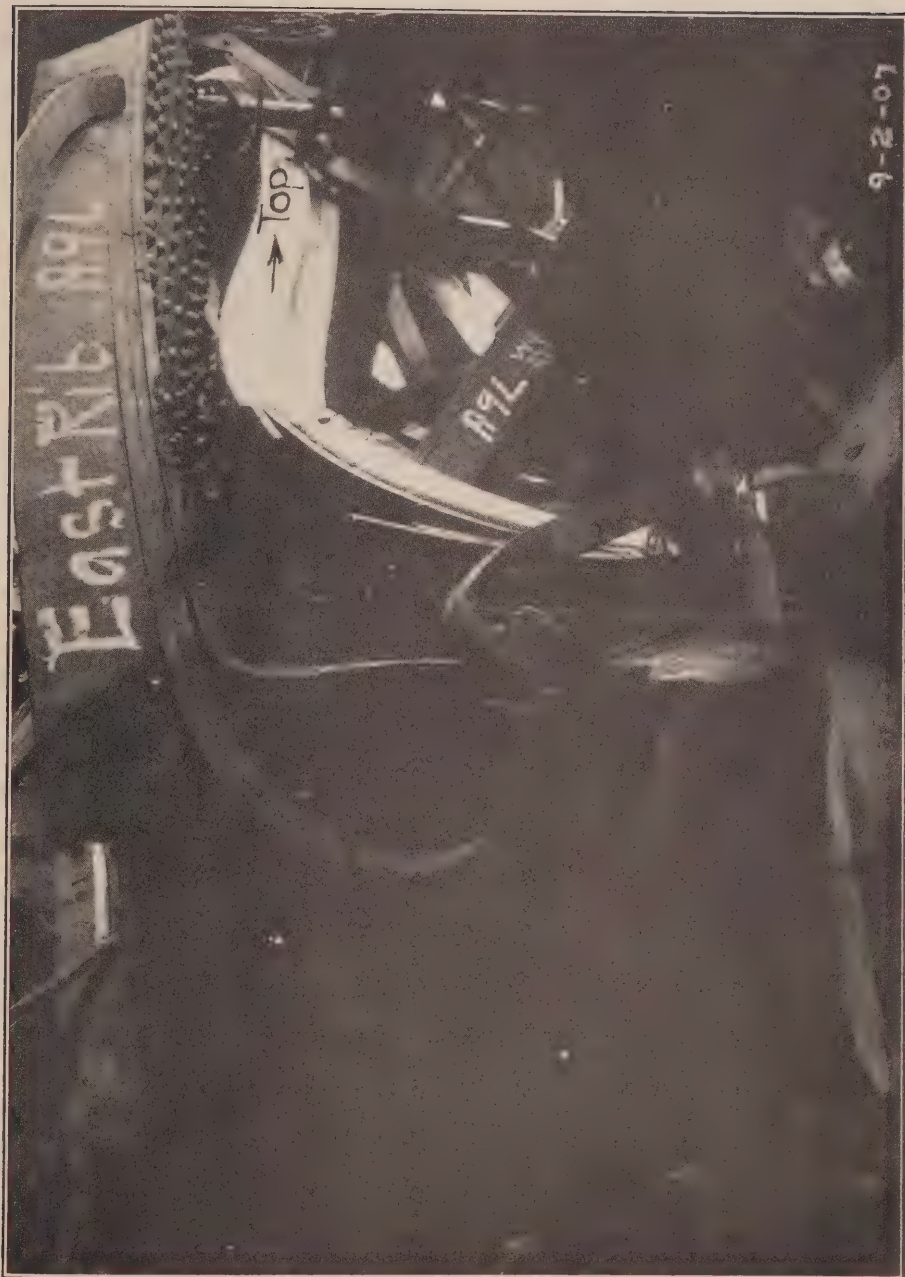
20. View of inner bend of chord 9, left truss anchor arm. The view is taken looking south and all four ribs are visible, the angle of the bend being roughly 90°. Date, Sept. 2, 1907.

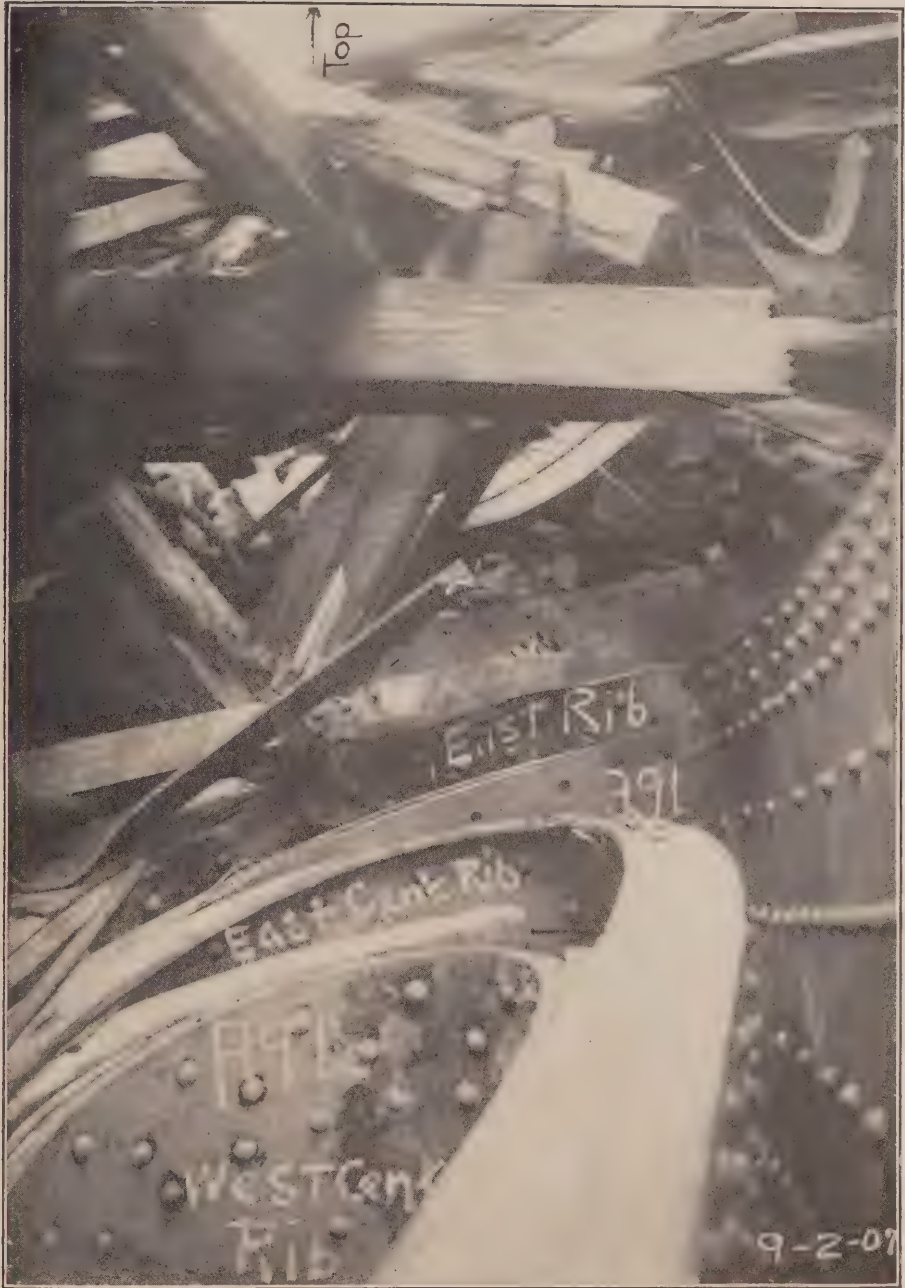
21. View of bend shown in 20, but taken looking north. Date, Sept. 2, 1907.

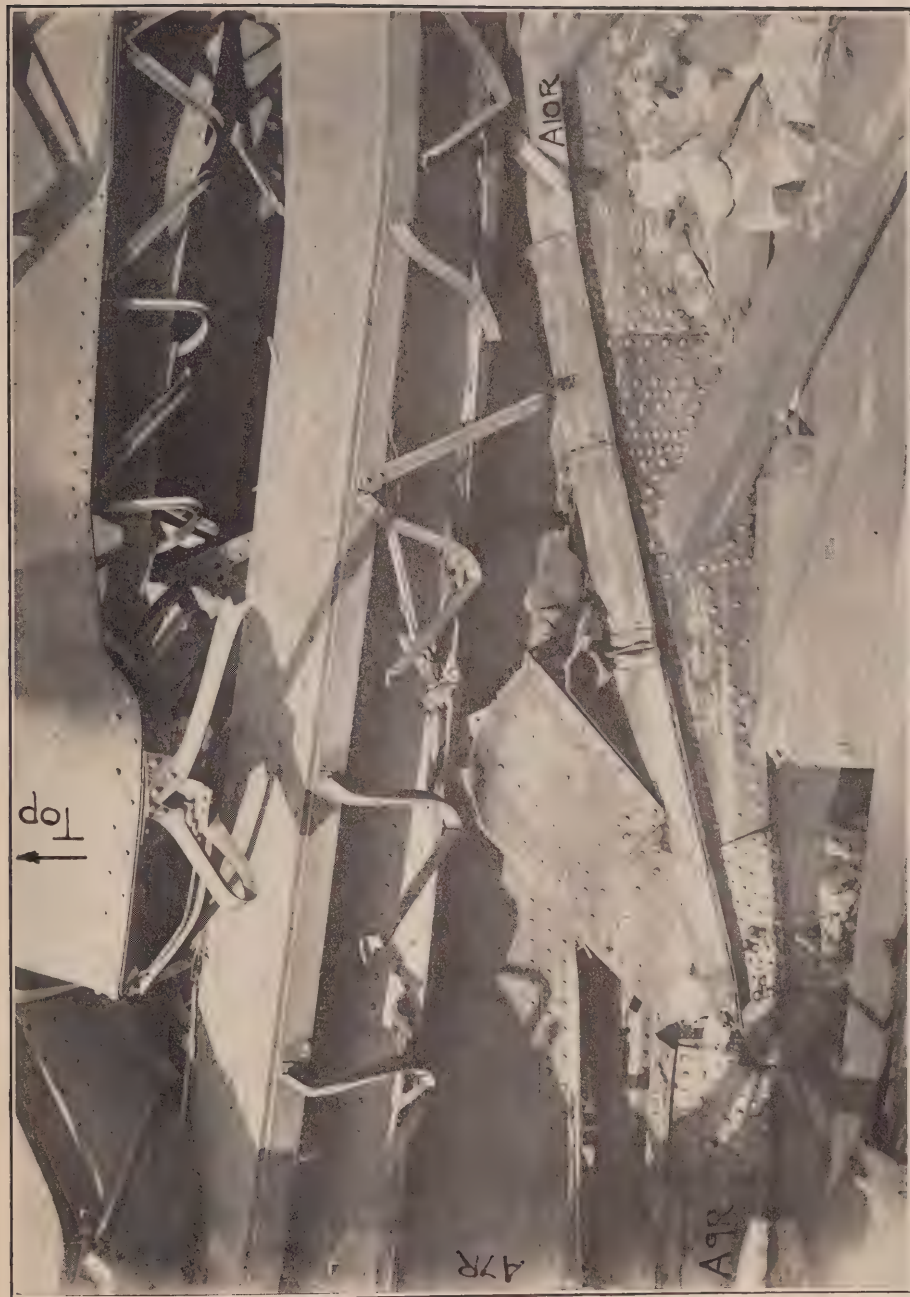
22. View showing the shop and field splices between chords 9 and 10 right truss, anchor arm. Note on the left that chord 9 passes under chord 7.

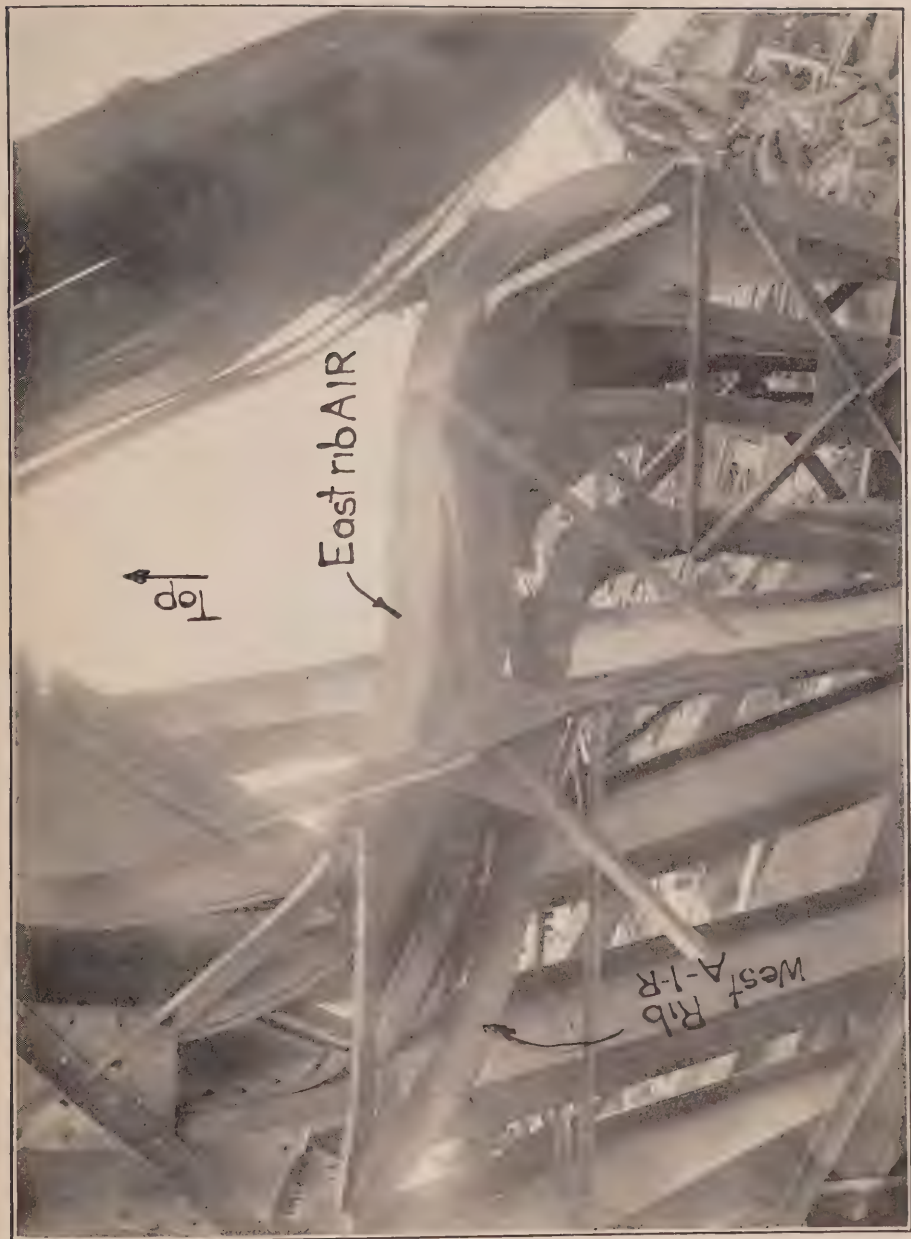
23. View of lower side of chord 1, right truss, anchor arm, taken looking north. Note the form into which the chord has buckled.

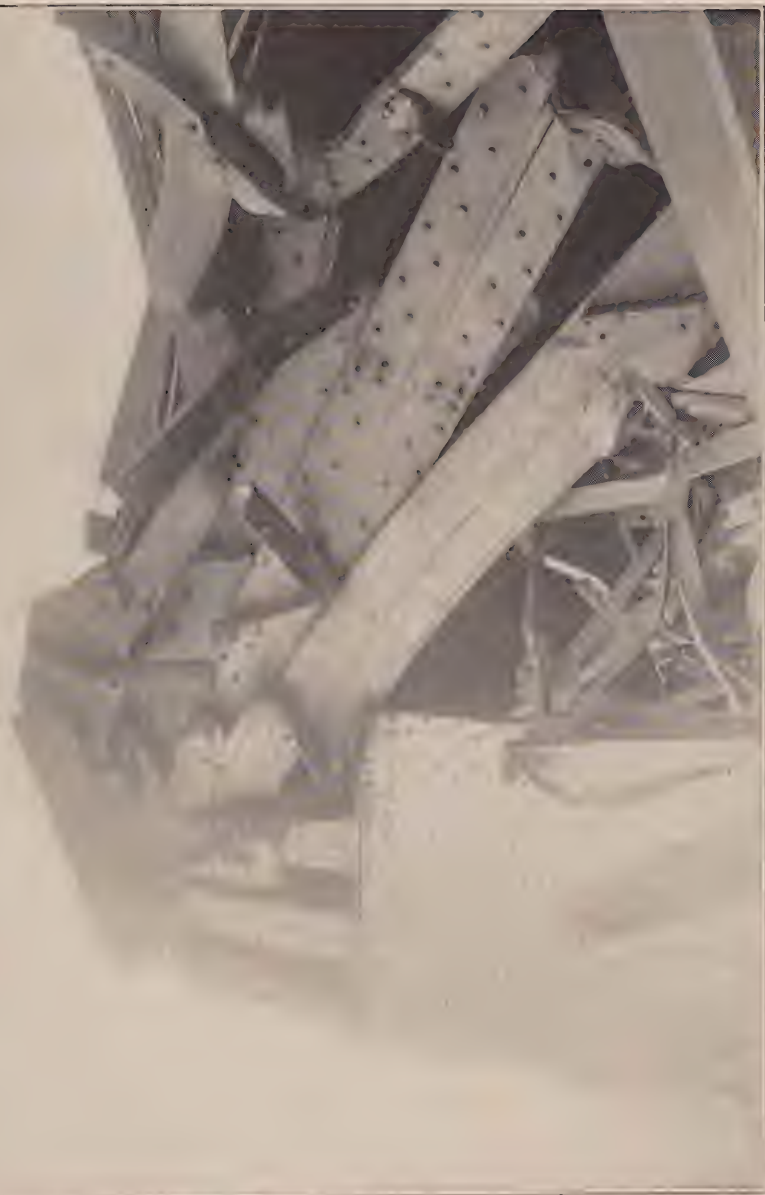
#4

4. Shows bending of portion of center post (C104). Note also the straight lines retained by the cover plates. The center post generally part of the same design as lower chumbe, being composed of four parallel with the addition of extra flange angles.

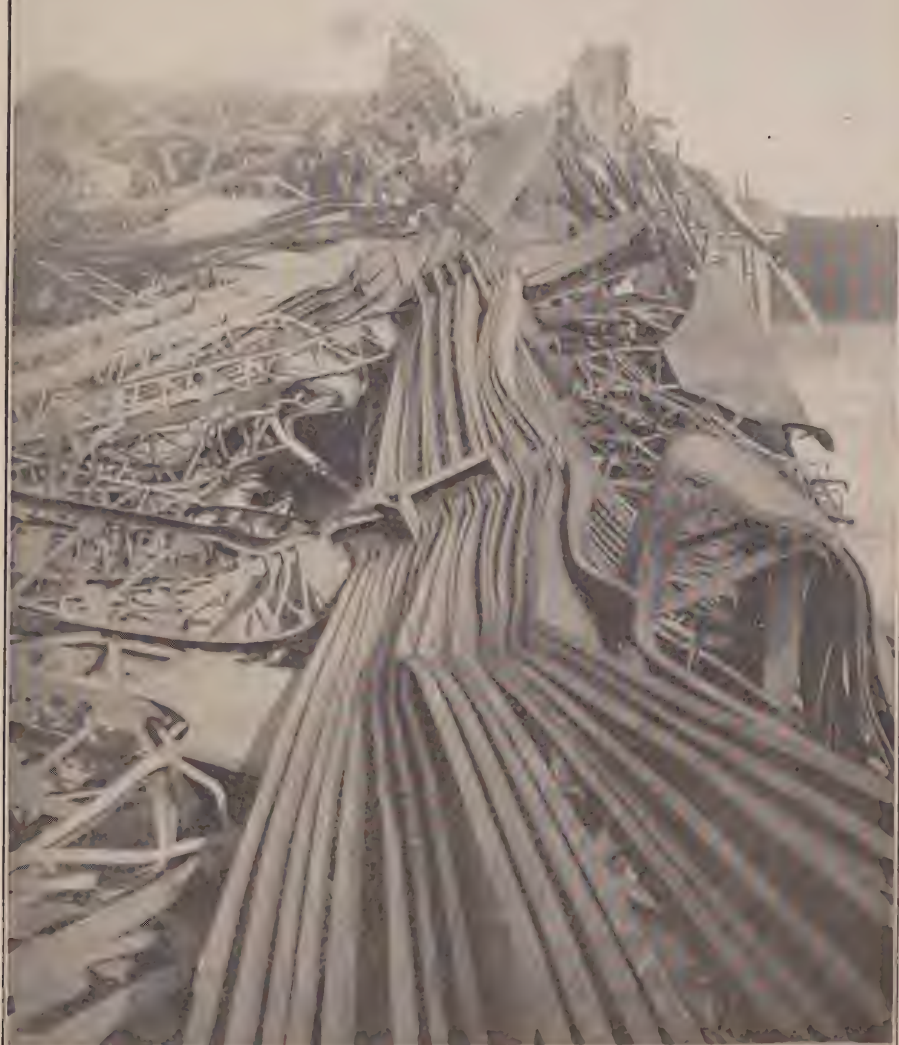
6

6. Shows the unbroken chain of eye-bars of the top chord of the Quebec side designated on the plans as AdR, AeR and AfR.

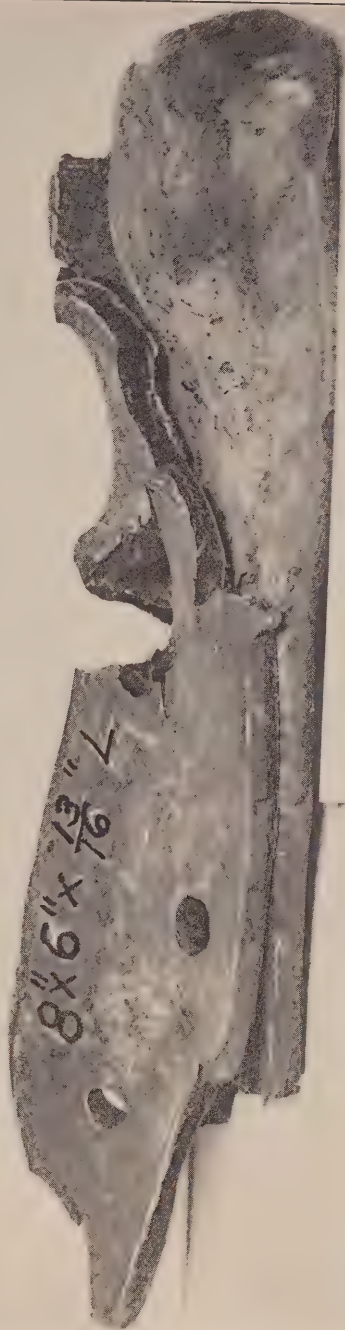
#14

13. Shows a fragment of an 8" x 6" x $\frac{13}{16}$ " angle torn to pieces and closed together to nearly close contact.

14. Shows another view of the angle shown in No. 13.

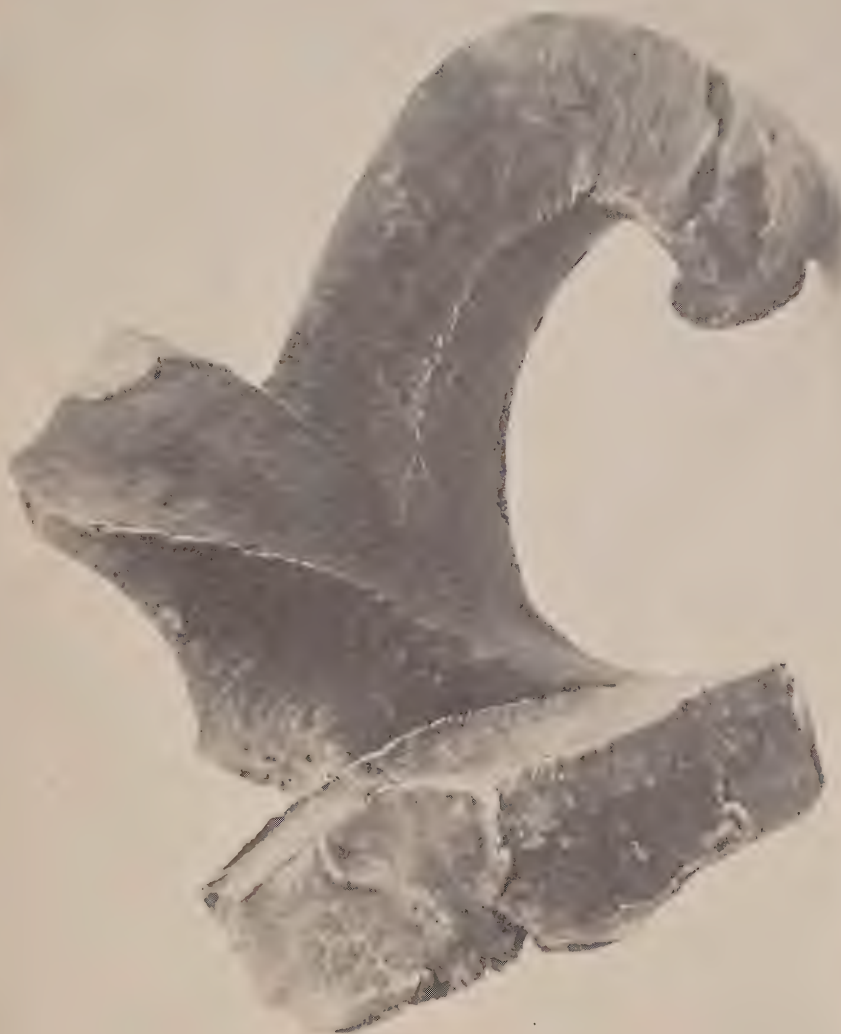
15

15. Shows a fragment of g'' plate torn, sheared and bent.
